Manhole Inspection Summary

Manhole # S41W1_010MH

Insp Date: **12/4/07 10:22 AM**

Location Address: **603 Anabel**

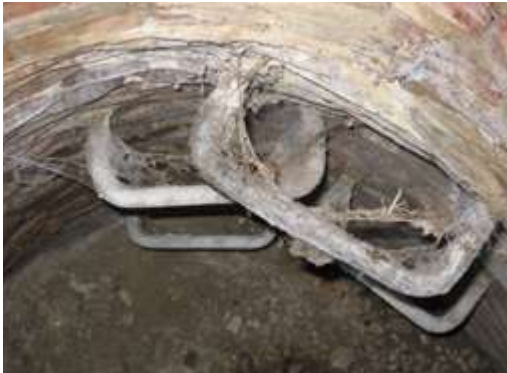
Steps Count: **4** Missing: **0** ☐ Corroded

steps

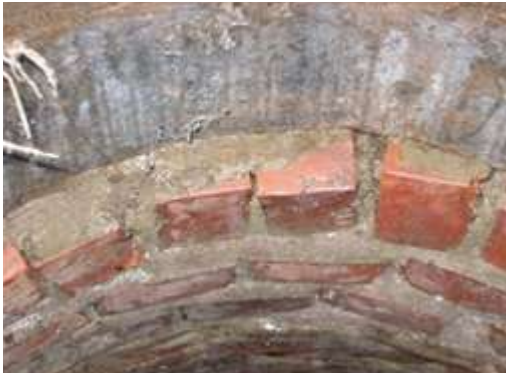
Defect 1

Frame Offset: **2** (in.) Condition: ☒ Sound ☐ Cracked ☐ Leaks

frame offset

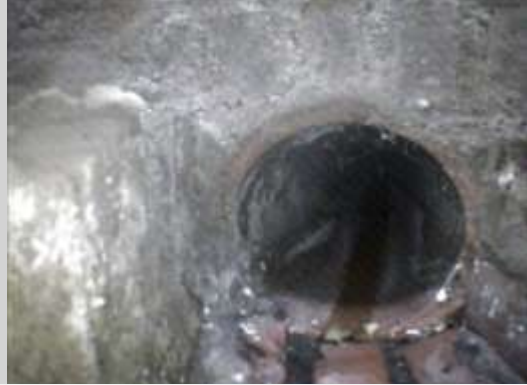
12 O'Clock Outflow

8 in. Circular Gravity Sewer
Pipe Out @ 12 O'Clock

Pipe Height: **10.8** (in.) Rod and Bar (Angled)
Pipe Material: **Clay** ☐ Pipe Lined
Invert Depth: **9.26** (ft.) Flow Characteristics: **Slow**
Deposits: ☒ None ☐ Mud ☐ Sludge ☐ Debris ☐ Grease
Silt Depth: (in.) Deposits Extent:
Infiltration: **None** Pipe Seal Cond: **Sound**

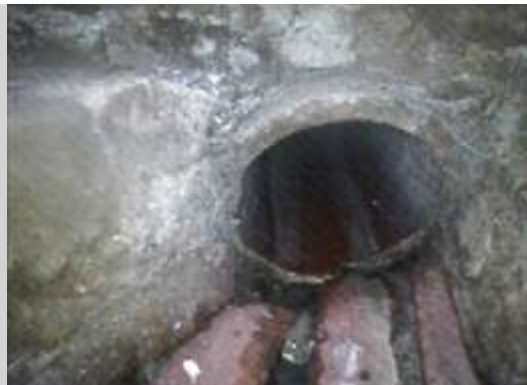
5 O'Clock Inflow

6 in. Circular Service Sewer
Pipe In @ 5 O'Clock

Pipe Height: **8.4** (in.) Rod and Bar (Angled)
Pipe Material: **Clay** ☐ Pipe Lined
Invert Depth: **8.70** (ft.) Flow Characteristics: **Slow**
Deposits: ☒ None ☐ Mud ☐ Sludge ☐ Debris ☐ Grease
Silt Depth: (in.) Deposits Extent:
Infiltration: **None** Pipe Seal Cond: **Sound**
